AFRL-ML-TY-TR-2004-4531

**Evaluation Of Elastomeric Polymers Used For External
Reinforcement Of Masonry Walls Subjected To Blast.**

A Thesis

Submitted to the graduate faculty of The University of
Alabama at Birmingham, in partial fulfillment of the
requirements for the degree of Master of Science in Civil
Engineering, Birmingham, Alabama, 2004

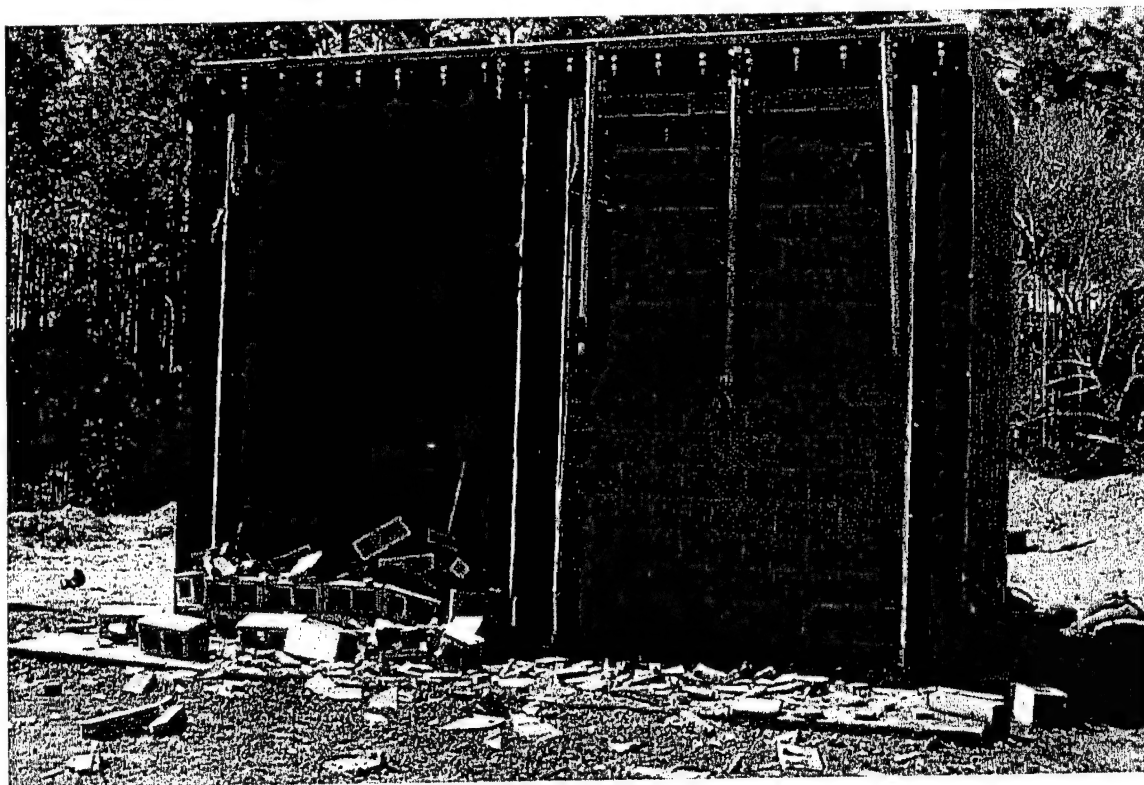
A post-test image of both walls is shown in Fig. 31. Defacing of the right wall is shown in Fig. 32. The control wall collapsed, as shown in Fig. 33. The polymer retrofit prevented the right wall from collapsing and prevented intrusion of wall fragments. Significant defacing of the CMUs near the top of the wall occurred.

FIG. 31. Test 1, Post Test Reaction Structure

The interior of the right (west) wall was retrofitted. The left (east) wall was painted (but not retrofitted), and the blocks were outlined. Both of the wall panels sustained major damage. The mortar layers at mid-height experienced the highest bending stresses and failed in tension. There was significant defacing of CMUs on the retrofitted wall. No debris entered the reaction structure through this wall.

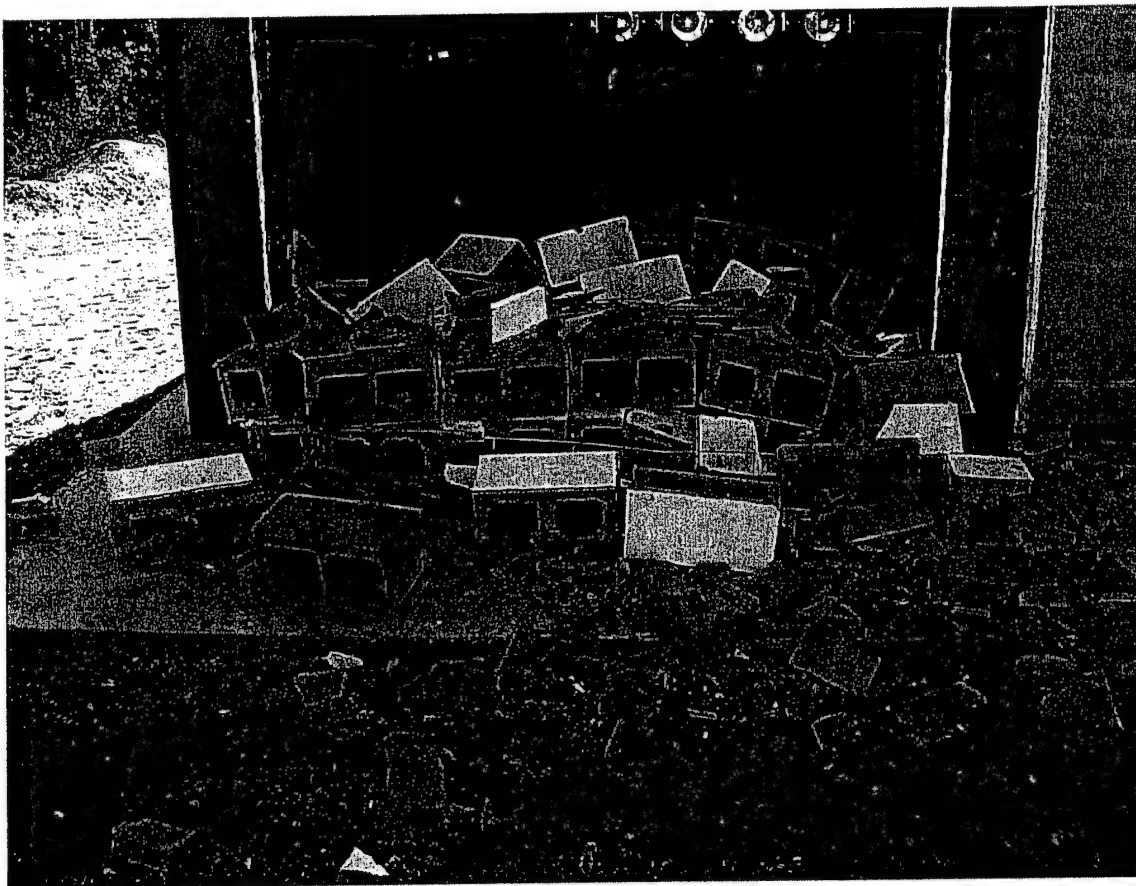
FIG. 33. Test 1, Collapsed Control Wall

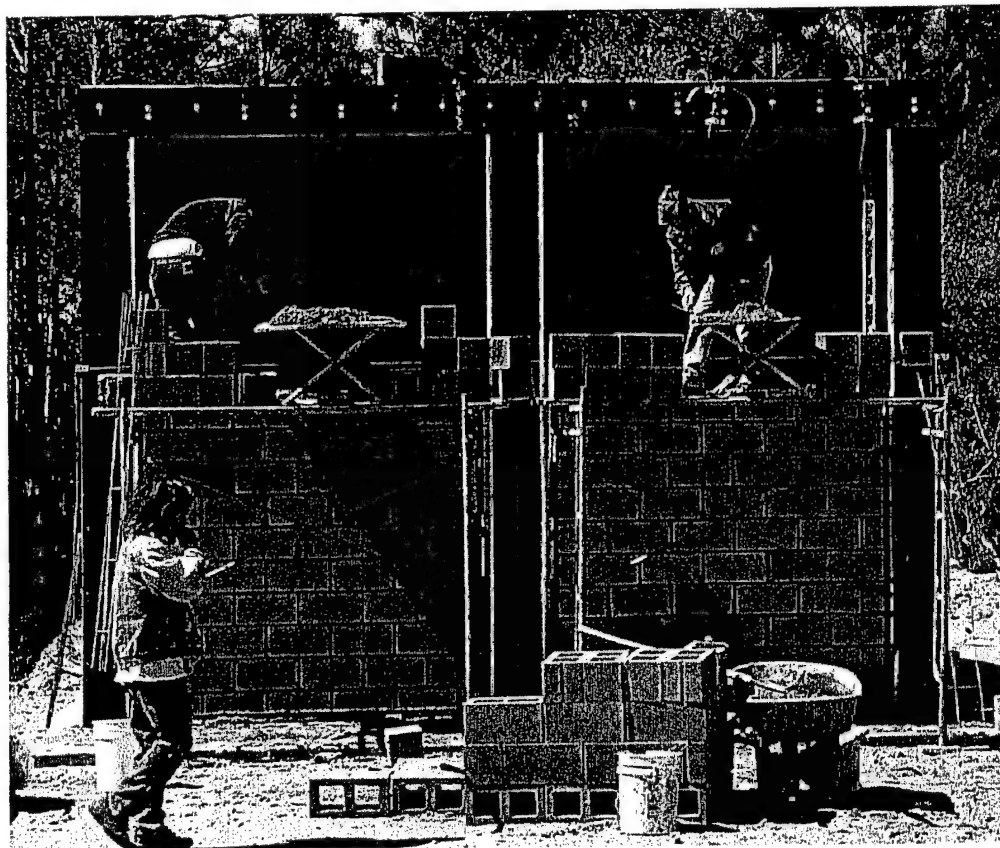
FIG. 39. Test 2, Wall Panel Construction

As in Test 1, two unreinforced masonry walls were constructed in the reaction structure. The walls measured approximately 7 ft 6 in. x 12 ft and were separated by a W12x35 I-beam and $\frac{3}{4}$ -in. foam insulation board on both sides of the wall panels. An existing 3 in. x 4 in. x $\frac{1}{4}$ in. angle iron locked the top and exterior side of the wall panel. There was a slight gap between the left masonry wall and the angle iron, and it was filled by wood shims. Caulking was applied between the masonry wall and foam insulation board to prevent dust from entering the structure. An image of the wall construction is shown in Fig. 39.

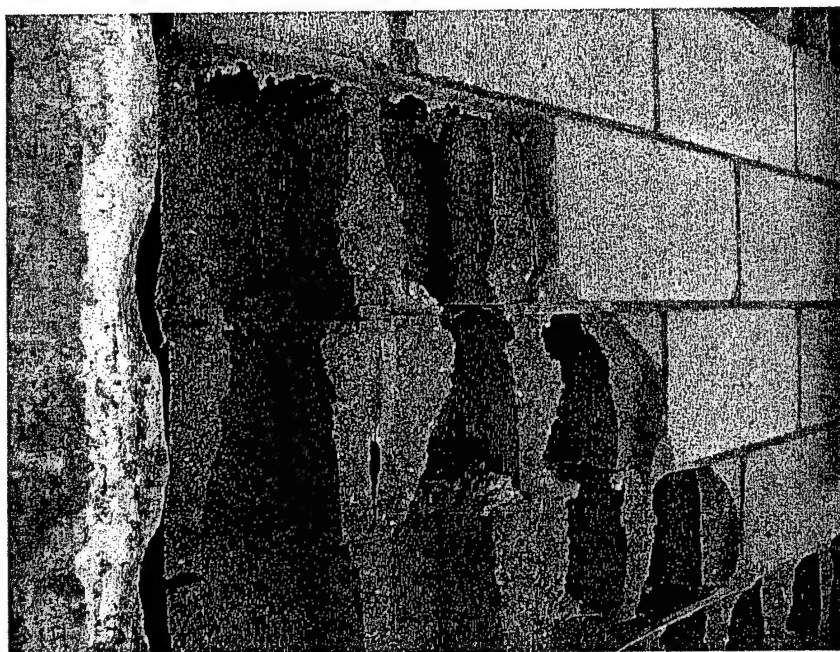
FIG. 91. Test 3, Mid Wall C

All laser gauges and the accelerometer failed to record data. Data from scratch gauges was used to determine deflections. Table 6 shows the predicted data compared to the recorded data. Figs. 83 through 93 show damage done from the blast.

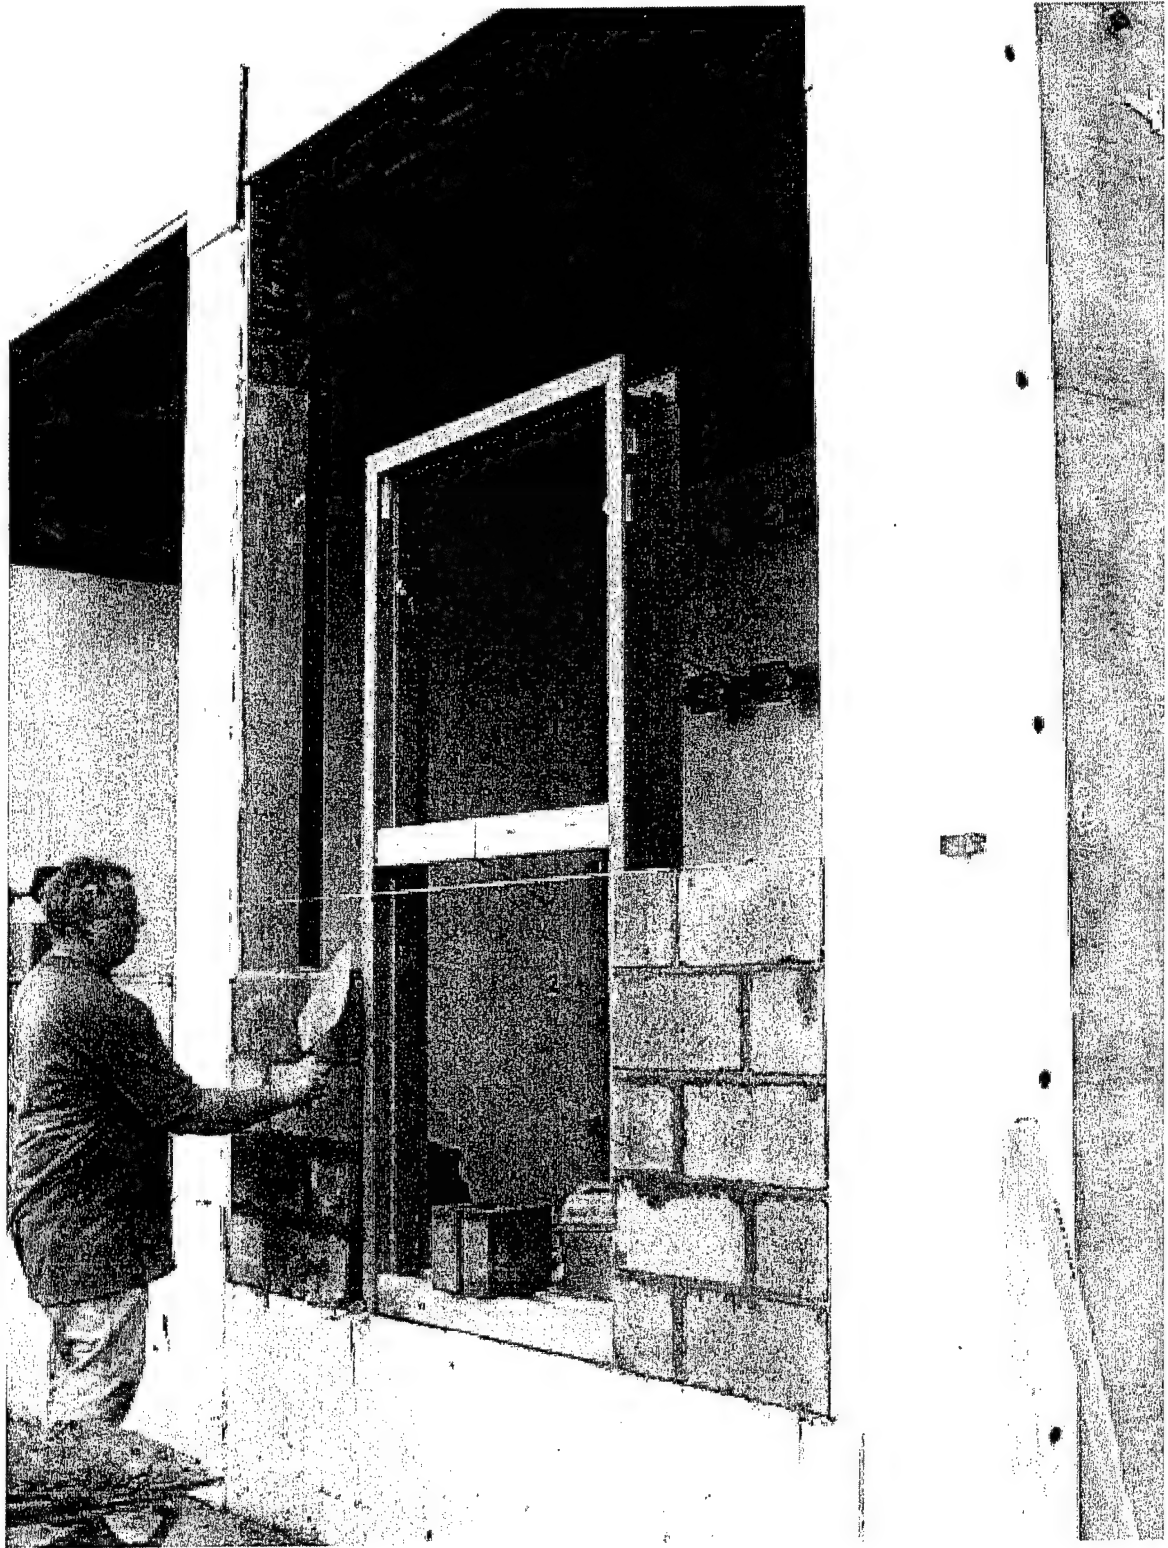
FIG. 96. Test 9, Door Installation

The doorframe was placed, spaced, and plumbed in the test structure before construction of the walls began. The wall was then constructed around the doorframe. As the wall was built, the hollow steel jam of the door was filled with mortar. A header was formed using solid bottom lintel blocks. After the wall cured, the door was hung. An image of the wall being constructed around the doorframe is shown in Fig. 96.

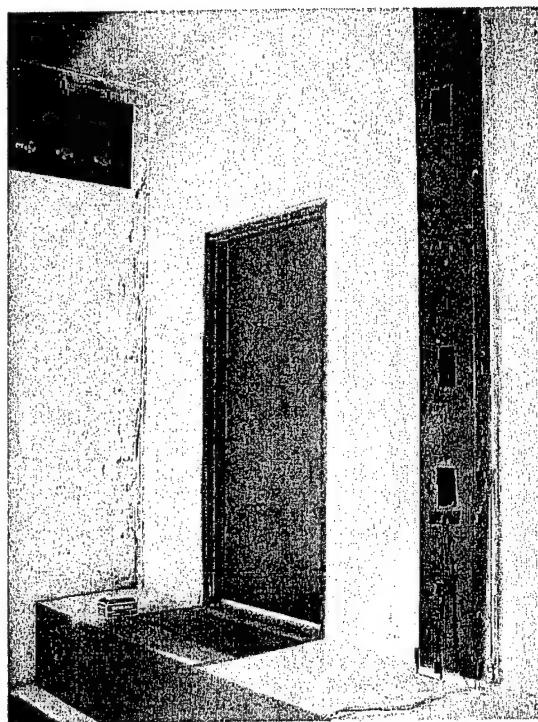
FIG. 103. Test 9, Wall with Door Completed

Fig. 99 shows the constructed wall with the door. Fig. 100 shows the window. Paper wrapping used to protect elements from polymer during spraying is shown in Fig. 101. Fig. 102 shows the coating process. The retrofitted walls are shown in Figs. 103 and 104.

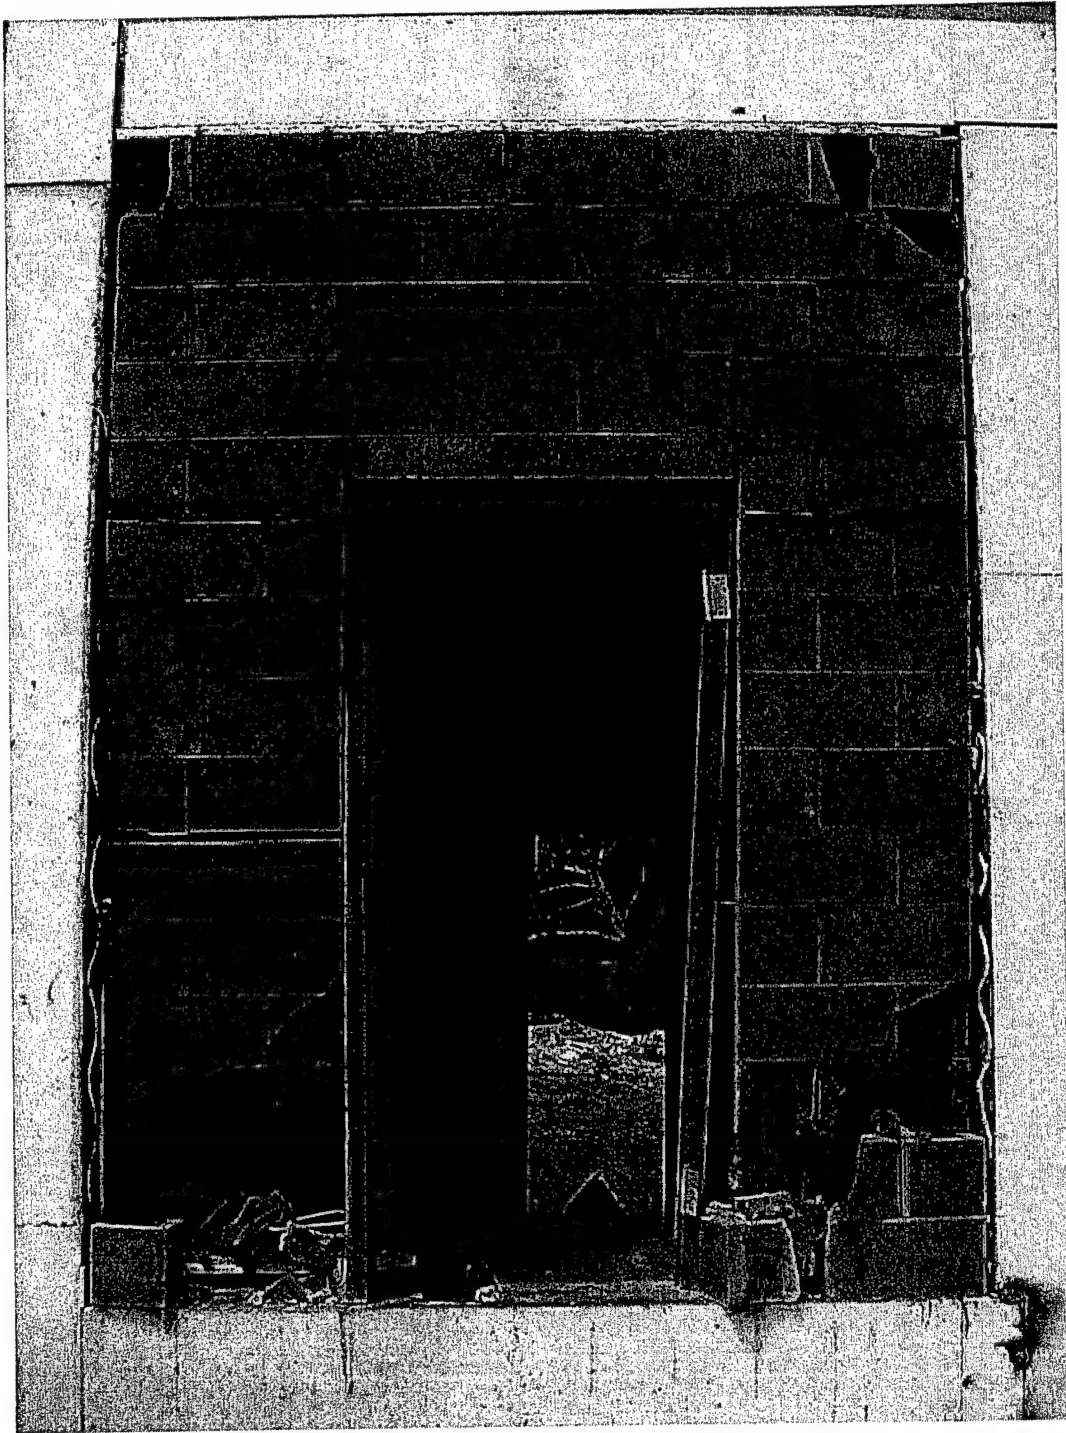
FIG. 114. Test 9, Posttest Door

Walls in this test did not collapse. However, there was extensive mortar joint cracking in both of the walls. The wall with the door had most cracks above the door. The frame of the door was shifted on one side. The polymer tore at the bottom. The wall with the window remained intact. However, there were cracks and defacing on the exterior.

An image of the door and window are shown in Figs. 114 and 115. The cracks are outlined with paint. The right wall contained the door. The left wall contained the window. Both of the walls survived the blast without collapse. The front face fracture for these walls covered more area than in other tests. In addition, there were cracks at many mortar joints. The doorframe was shifted and bent during the test. However, it resulted in no additional flying debris. Debris did enter the structure through the bottom of the wall containing the door.

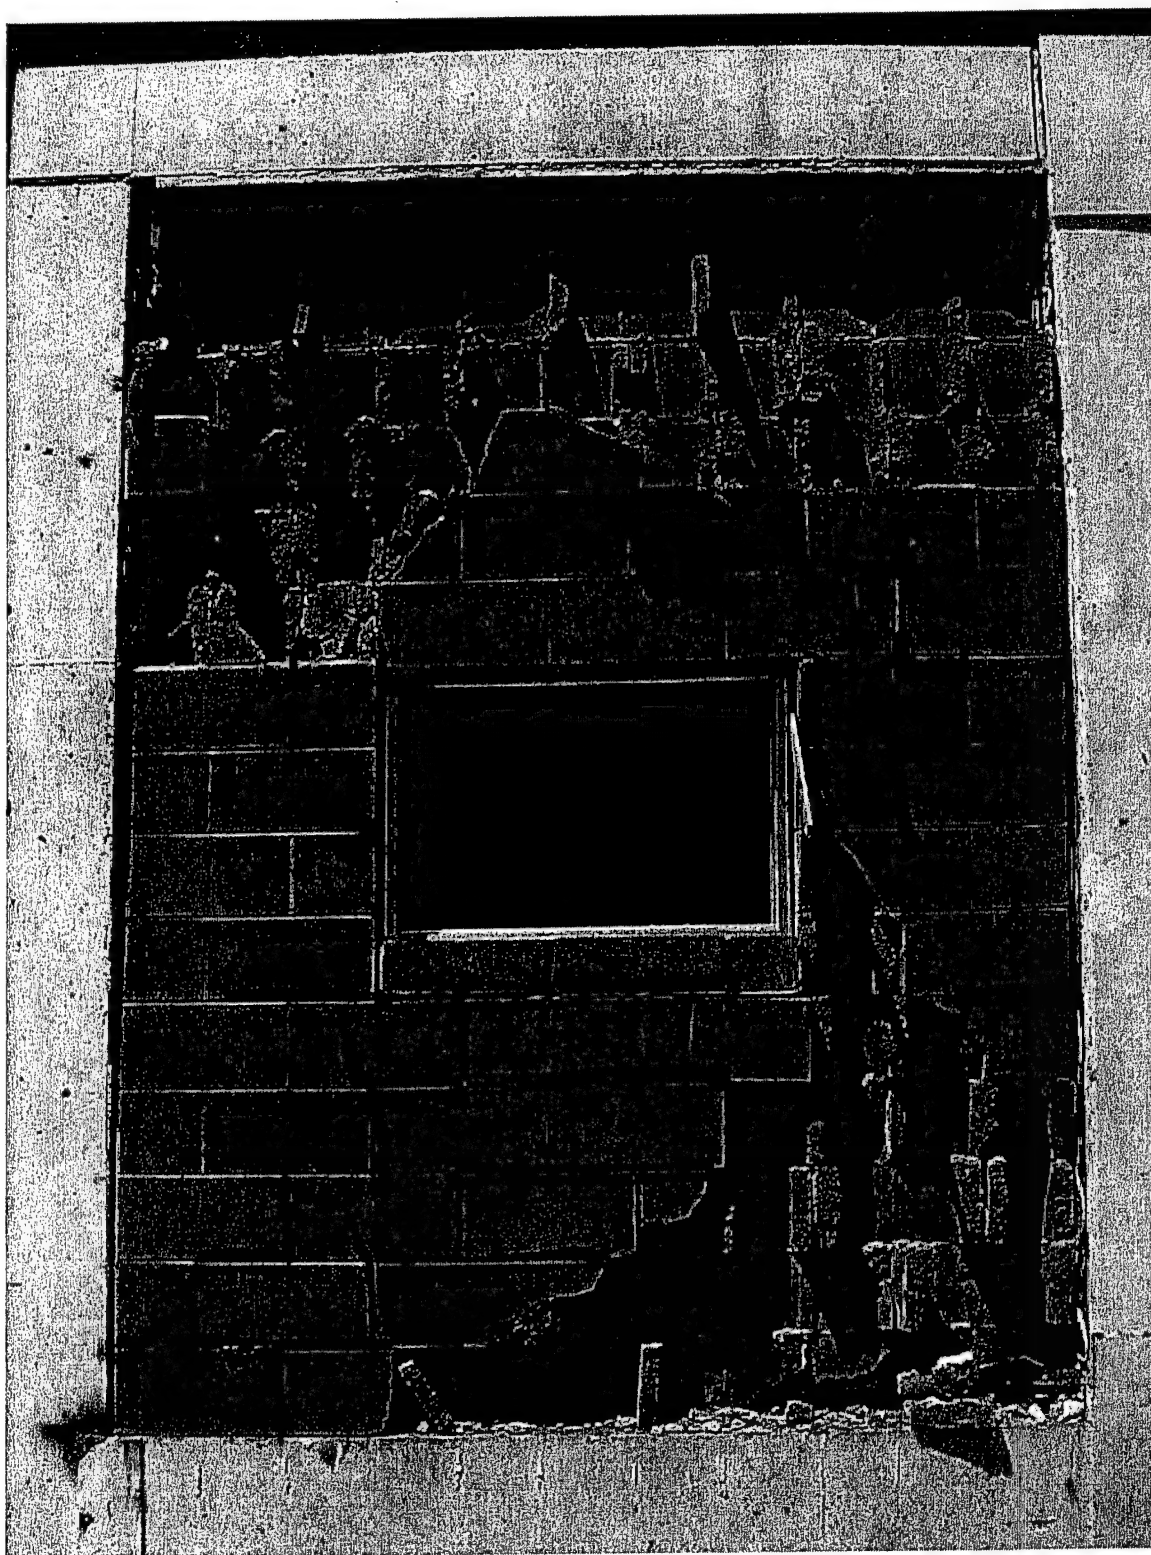
FIG. 115. Test 9, Posttest Window

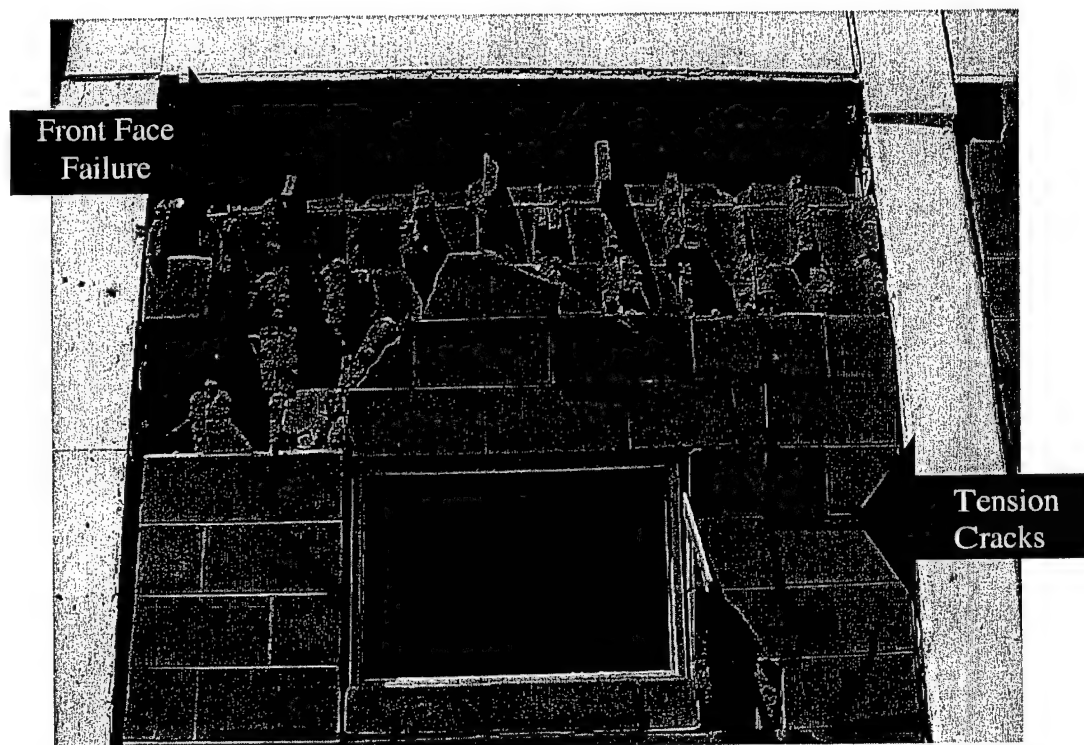
FIG. 116. Test 9, Top Left Wall Defacing

The mortar bond between the blocks is weak in tension. When the blast load reaches the structure, the shock wave fractures some of the front faces of the blocks and breaks some of the mortar bonds. The wall then flexes inward causing high shear in the upper and lower mortar joints followed by tension failure at the inside center of the wall. The negative phase of the blast loading then pulls the wall back outward. During these movements, mortar joints in the walls fail. This causes cracking throughout the lateral mortar joints.

The front face and mortar failures occur in the first few milliseconds after the blast is detonated. Close-up images of mortar and front face failures are shown in Figs. 116 through 118. Also shown in these images are large cracks, resulting from tension in the walls caused by flexure.

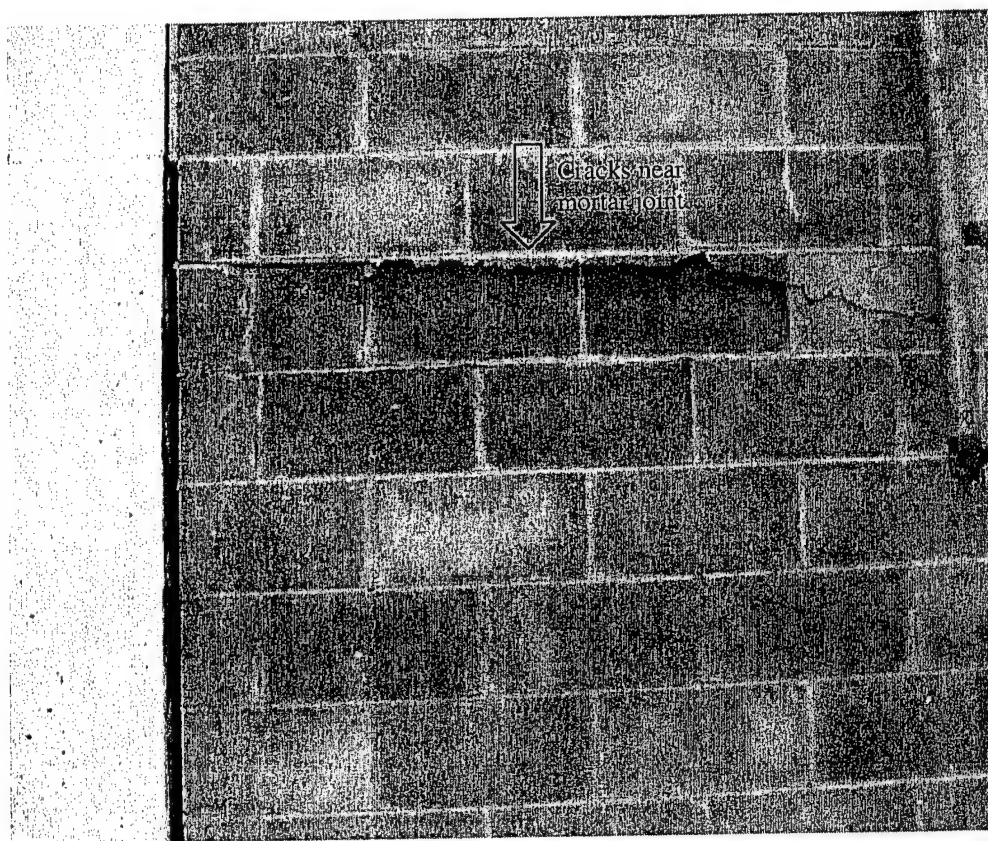
FIG. 135. Test 10, Shear Cracks, Left Side

FIG. 136. Test 10, Left Side Interior Tear

FIG. 137. Test 10, Protruded Block, Left Side

FIG. 138. Test 10, Shear Cracks, Right Side

FIG. 139. Test 10, Right Side Interior Tear

The polymer coating on the interior of the wall experienced a tear due to shear from mortar joint failure. A tear easily propagates once initiated. Mortar joint failure and consequent tears in the polymer are shown in Figs. 135 through 139. The steel door is shown in Fig. 140.

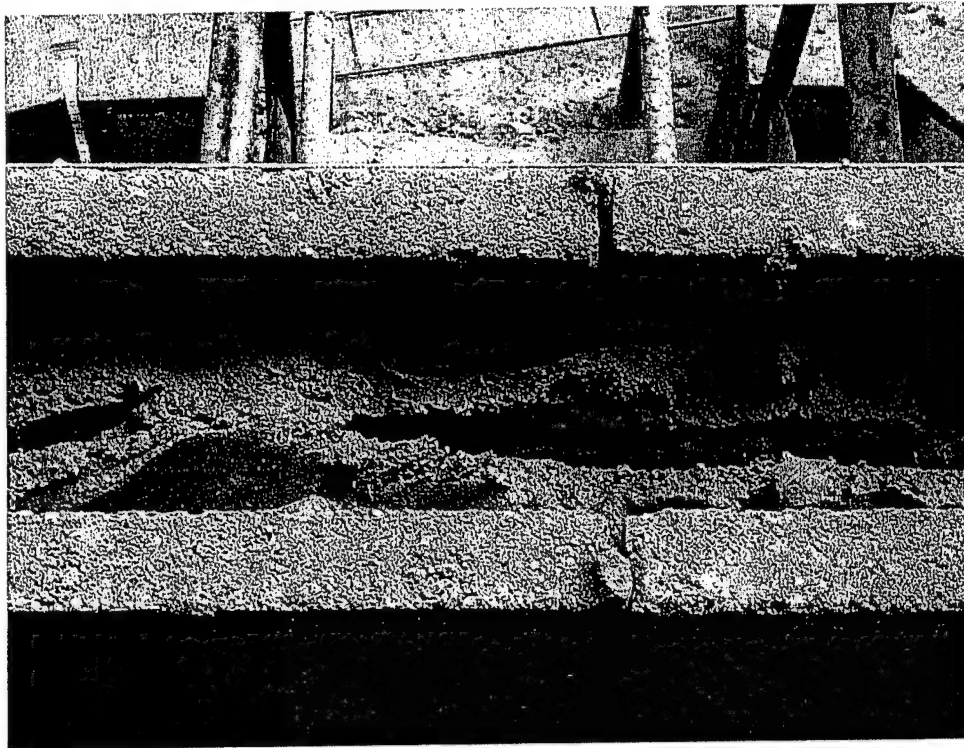
FIG. 144. Test 11, Blocks Beneath Window

FIG. 145. Test 11, Wooden Stand-in Frame

FIG. 146. Test 11, Empty Lintel Blocks

FIG. 147. Test 11, Lintel Blocks with Rebar

FIG. 148. Test 11, Complete Lintels

FIG. 149. Test 11, Completing the Construction

Holes were drilled in the 2 in. and 6 in. sides of the C-channel to attach the front and back flanges of the frame. The front flange contained holes to allow the frame to be attached to the CMU wall with toggle bolts. The interior flange was punched with 1¼-in. diameter holes spaced ¼ in. apart across the entire surface of the flange. This was done to allow the polymer coating to adhere to the underlying CMU block as well as to hold the frame to the wall. An image of the cross-section of the window is shown in Fig. 142. A drawing of the complete frame is shown in Fig. 143. Images of wall construction are shown in Figs. 144 through 149. The completed wall is shown in Fig. 150.

The window fabrication could not be completed until the wall was constructed. A 2 in. x 4 in. wooden frame was placed in the wall to "stand in" as the wall was built. The opening of the window was placed near the center of the wall. The window was located 75 in. from the left wall, 80 in. from the right wall, and 31 in. above the floor slab. The insides of the masonry blocks below the window were filled with grout. Blocks on the sides of the window were left unfilled. 4.8-in. sections of 5/8-in. diameter rebar were

placed in four lintel blocks located just above the window. The blocks were then filled with mortar.

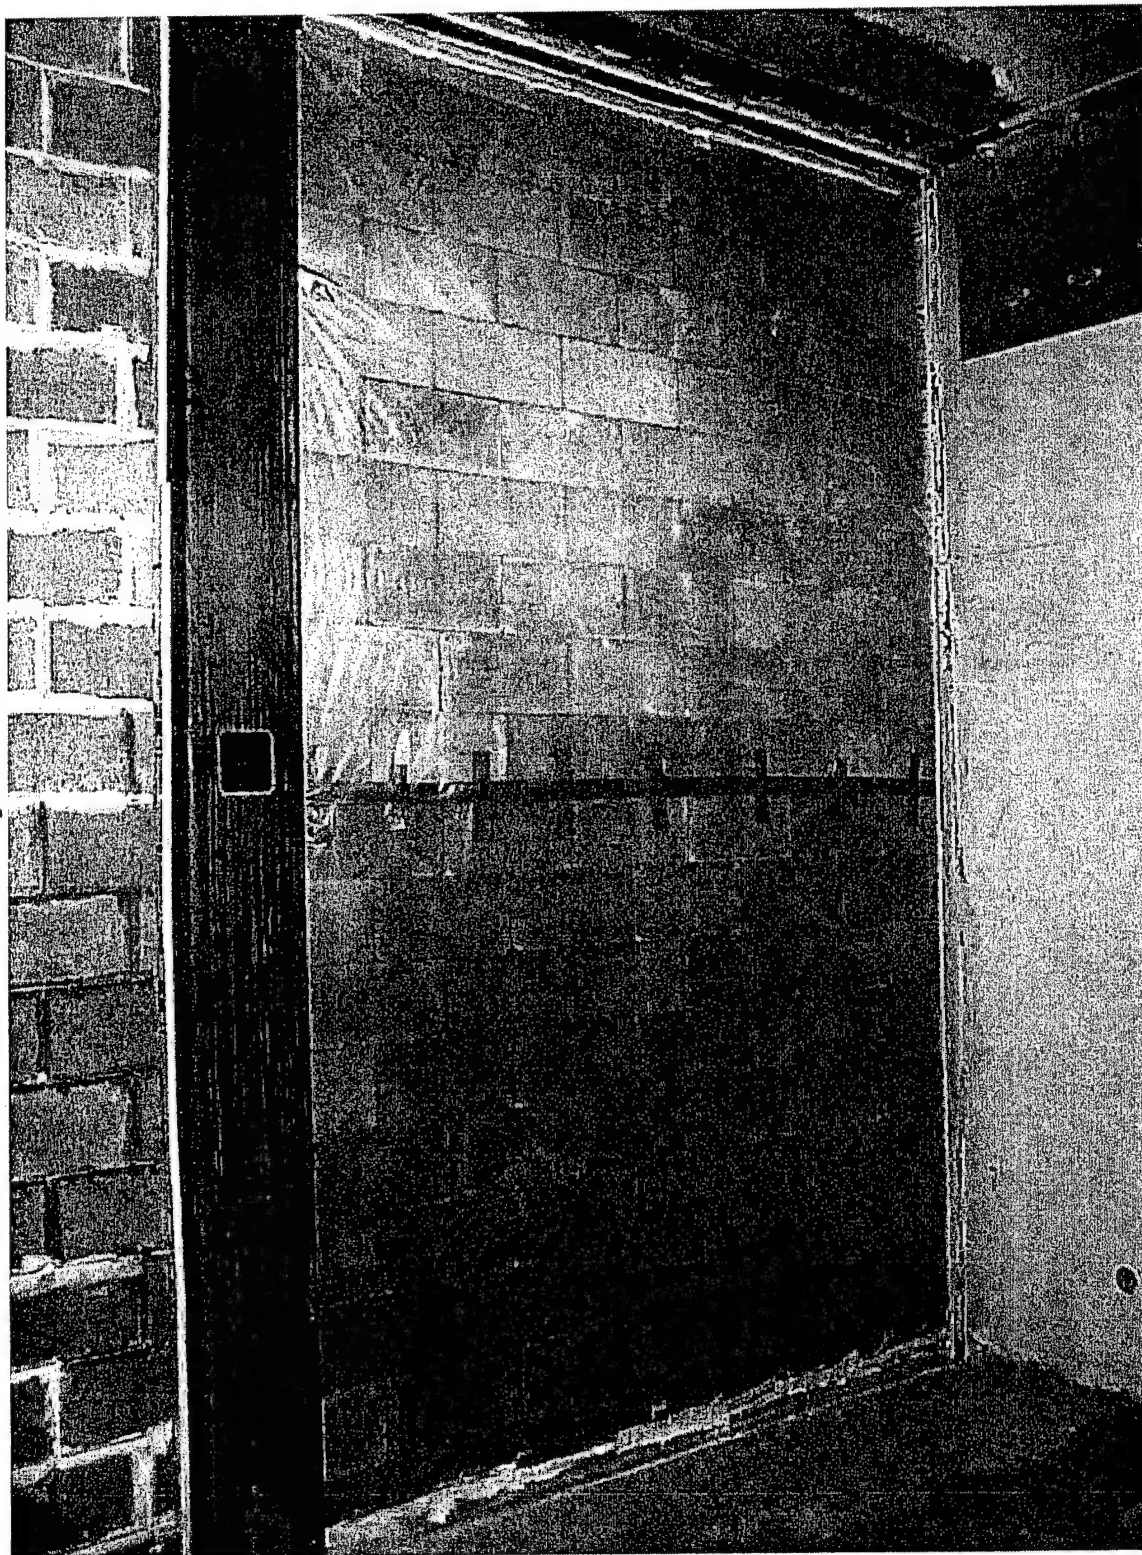
FIG. 184. Test 12, Left Wall Inside, Plastic Covering

After the mortar dried, the plastic was trimmed to fit the wall. It was attached to the wall with double-sided tape. Creases were eliminated as the plastic was taped. The trimmed and taped plastic is shown from the inside in Fig. 184. A drawing of the walls, plastic, and retrofit is shown in Fig. 185.

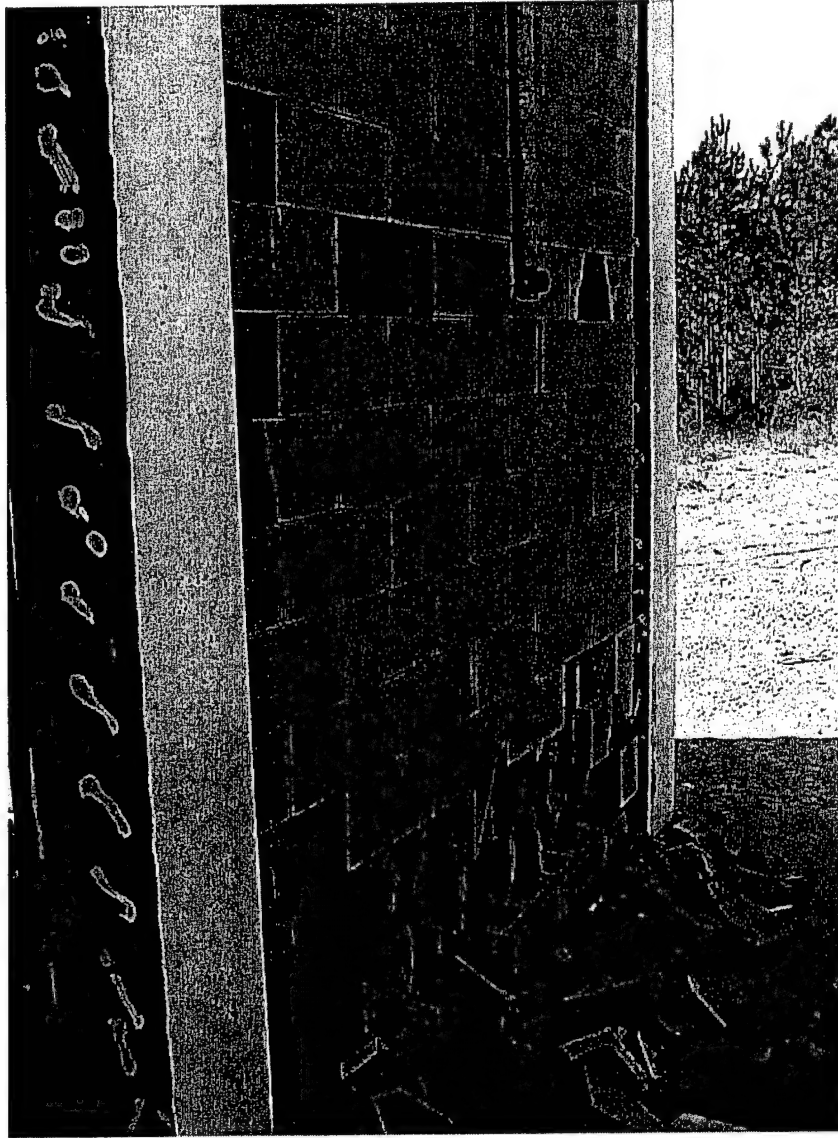
FIG. 202. Test 12, Right Wall, Bottom

The lack of mortar on the walls did not prevent the polymer retrofit from being effective. Deflection data from D2 shows that the wall deflected inward approximately 8 in. and then outward about 4 in. Even deflecting outward, the polymer held the wall together. Some of the top row blocks sheared out. Furthermore, there appeared to be great arching forces due to the lack of mortar. Gravity collapse is predicted when the deflection of the wall equals the thickness of the wall and the right wall deflected more than its thickness. With the application of the polymer, however, the wall can deflect more without collapse. Images of the right wall are shown in Figs. 201 through 205.

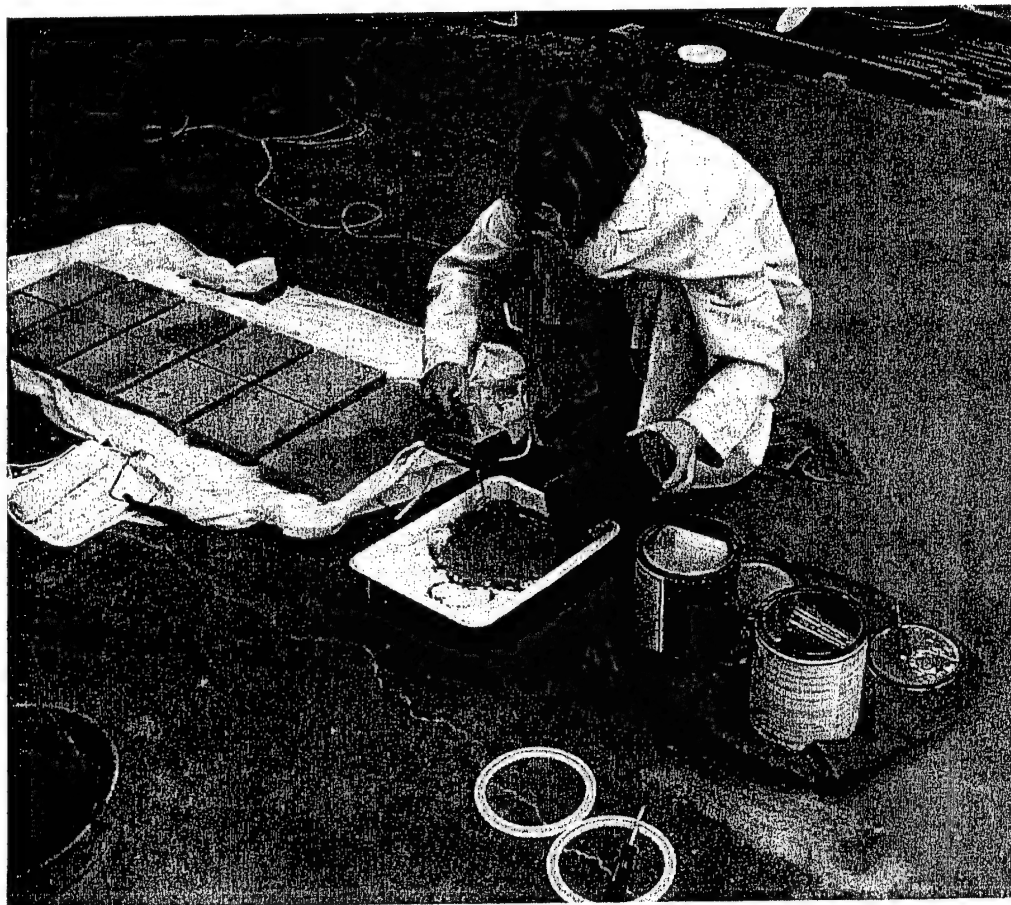
The two components of the Futura-Bond primer were mixed individually in separate containers, then mixed together at a 1:1 ratio in the paint tray. This was done using a small kitchen mixer. The process is shown in Fig. 208. The clayed blocks are also shown.

FIG. 208. Priming Mixture and Clayed Blocks

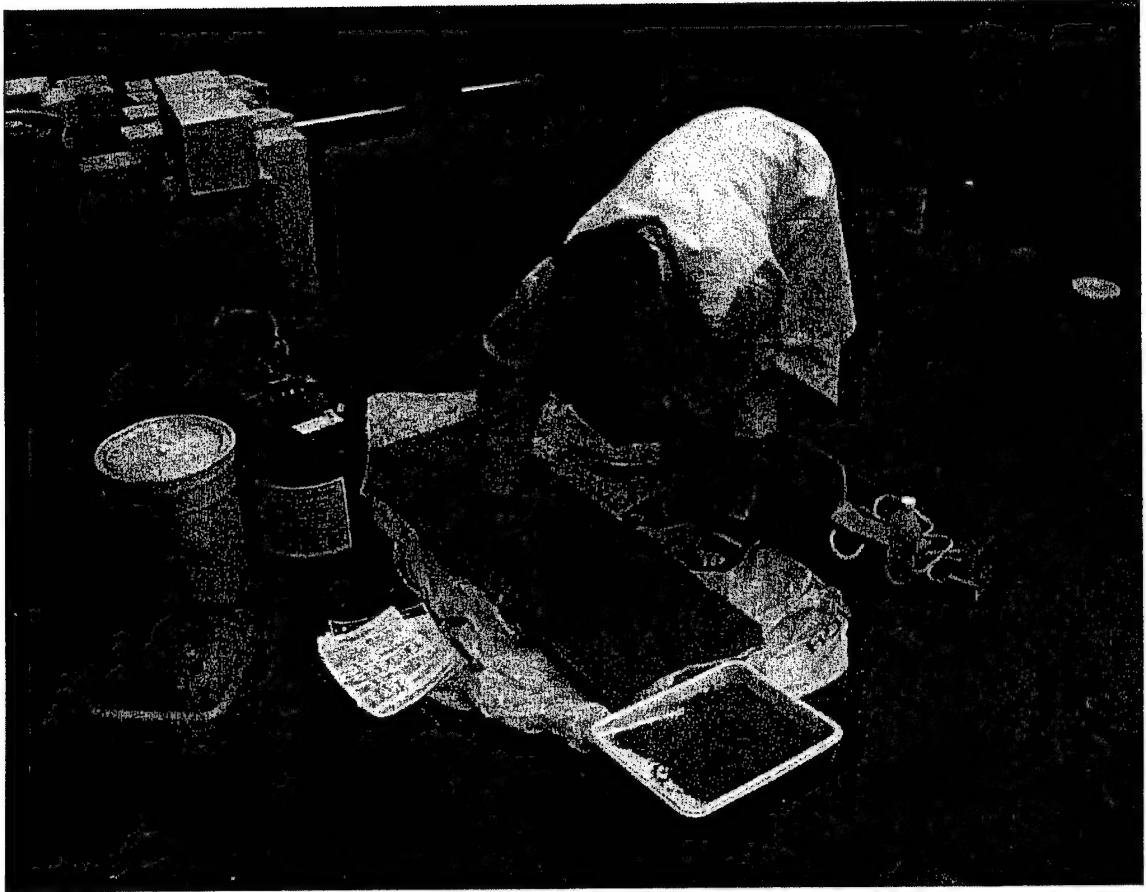
Once mixed, the primer was applied with a paint roller to all six of the concrete blocks. It was allowed several days to dry before any additional work was done. The process is shown in Fig. 209. The primed blocks are shown in Fig. 210.

FIG. 209. Priming Process

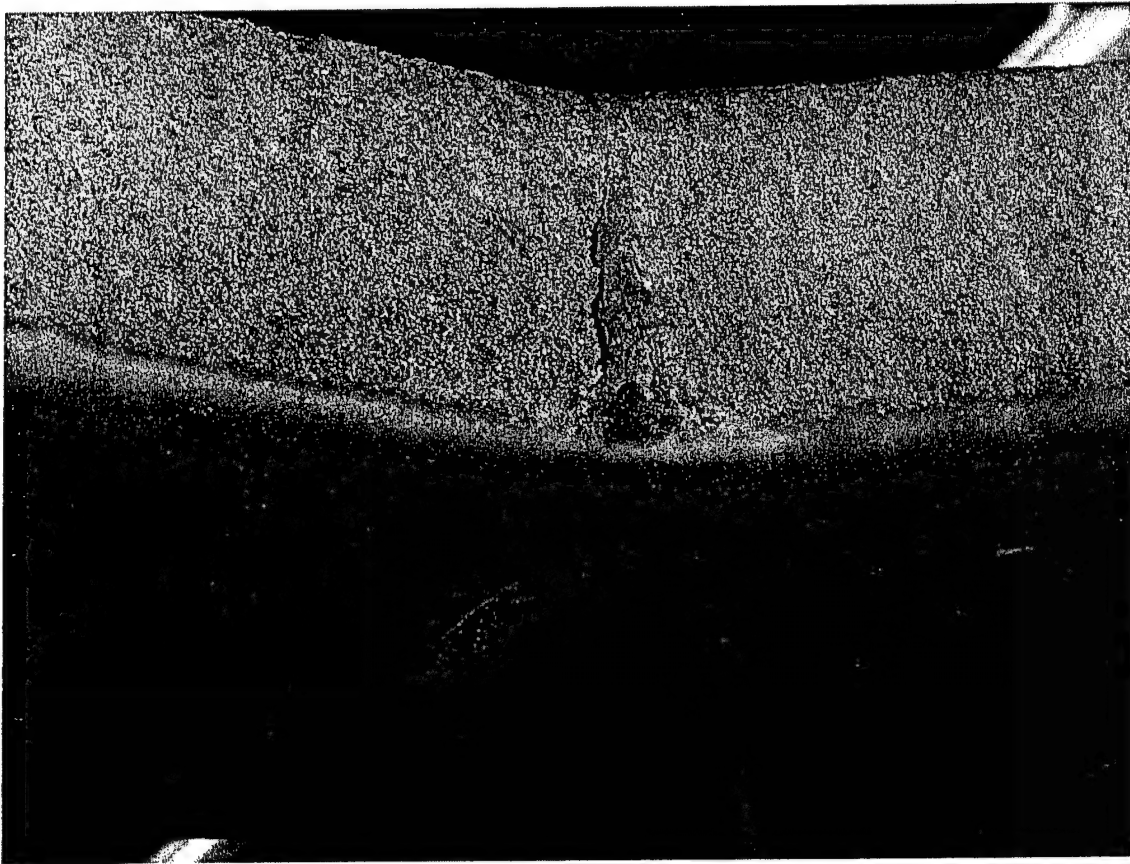
At approximately 900 lb, the elastomeric polymer started to tear. However, the polymer was still resisting load. When the applied load reached 1100 lb, the deflectometer was removed in anticipation of the collapse of the block onto the data collection equipment. The block collapsed at a load of 1160 lb. Fig. 217 shows the tear in the polymer as well as the size of the crack in the concrete.

FIG. 217. Elastomeric Polymer after Tearing

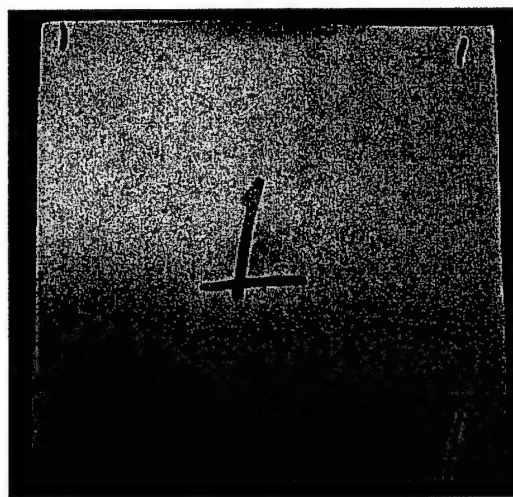
Polymer Sample 1 was placed in the testing machine. An aluminum projectile with a diameter of approximately $\frac{1}{2}$ in. and a mass of 7.35 lb was dropped from the top of the tower. The material was not punctured, and very little permanent strain was evident. An image of Polymer 1 is provided in Fig. 225.

FIG. 225. Drop Tower Impact Test, Polymer 1

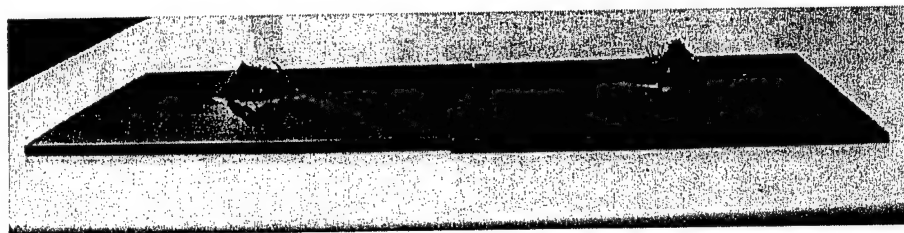
Polypropylenes 1 and 2 were placed in the supports and then in the testing machine. The 7.35-lb mass was used for both samples. Images of the polypropylene/polypropylene woven samples are shown in Figs 233 through 235. Sample 1 is on the left; Sample 2 is on the right.

FIG. 233. Drop Tower Impact Test, Polypropylene Samples Top View

FIG. 234. Drop Tower Impact Test, Polypropylene Samples Side View

FIG. 235. Drop Tower Impact Test, Polypropylene Samples Bottom View

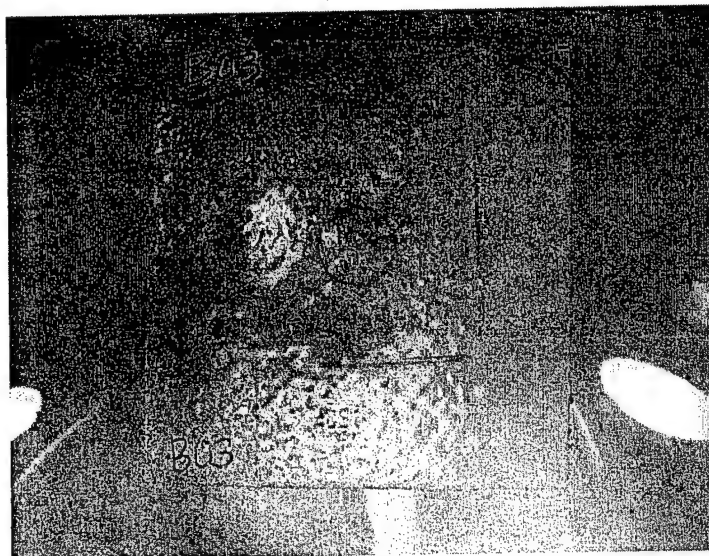
After the initial pressures were determined, the first specimen, Blunt Object 1 (BO1), was fired and completely penetrated the sample and exited with a significant velocity due to the difference in thickness of the thicker trial specimen compared to the thinner setup specimen. For the second specimen (BO2), the pressure was reduced to 27 psig. Even with the reduced pressure, the projectile still exited the specimen. For the third specimen (BO3), the pressure was reduced to 13.5 psig. This projectile did not penetrate the polymer sample. With the first two specimens, an entrance velocity reading was acquired. With the third, however, no data was obtained since the projectile did not penetrate the polymer. Images of the first, second, and third specimens are shown in Figures 246 through 248.

FIG. 246. Gas Gun Test 1, Specimen One

FIG. 247. Gas Gun Test 1, Specimen Two

FIG. 248. Gas Gun Test 1, Specimen Three
